Aquatic and Terrestrial Connectivity at Select Road-Stream Crossings in the North and South Branch Raritan Watershed Region (WMA8) of New Jersey, USA

A project report from
Raritan Headwaters Association
Submitted to NJ Division of Fish and Wildlife,
Endangered and Nongame Species Program
August 15, 2022

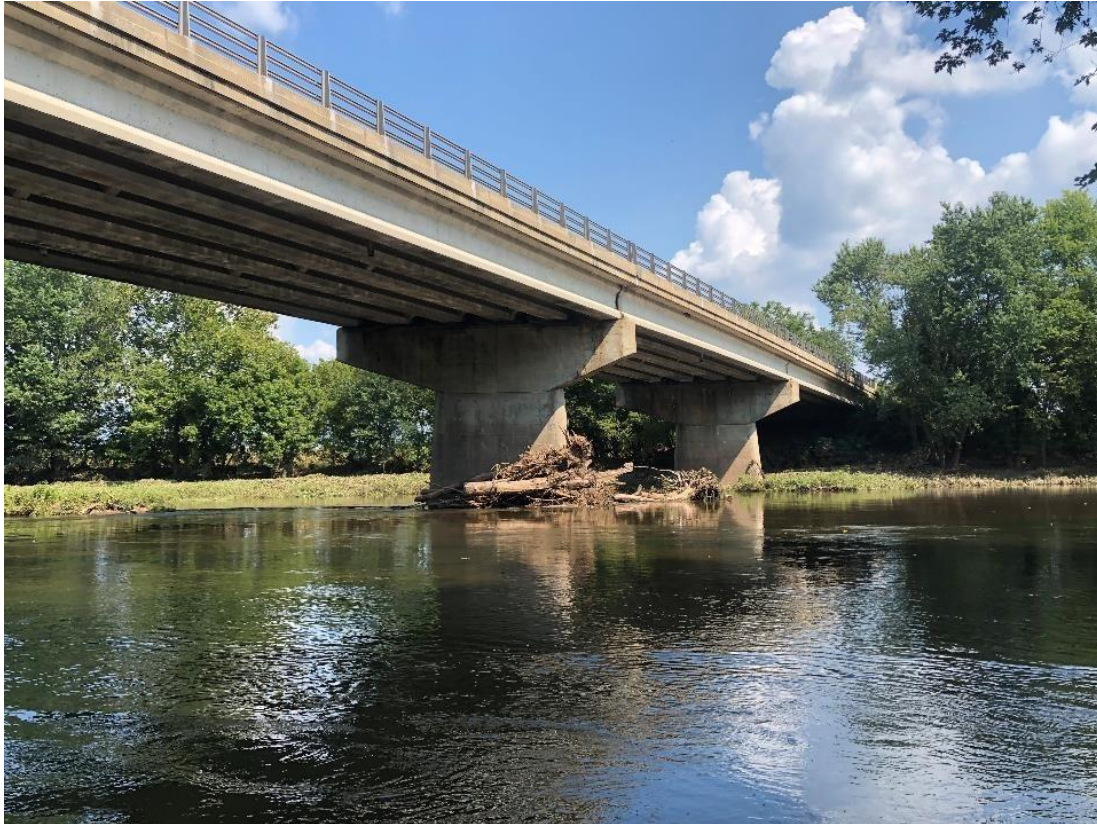
Cover photo Crossing Structure on the South Branch Raritan River in Hillsborough, NJ.
